DEVELOPMENT OF MATERIALS AND PROCESS TECHNOLOGY FOR DUAL ALLOY DISKS

FINAL REPORT

**NATIONAL AERONAUTICS and SPACE ADMINISTRATION
NASA LEWIS RESEARCH CENTER**

CONTRACT NAS 3-21351

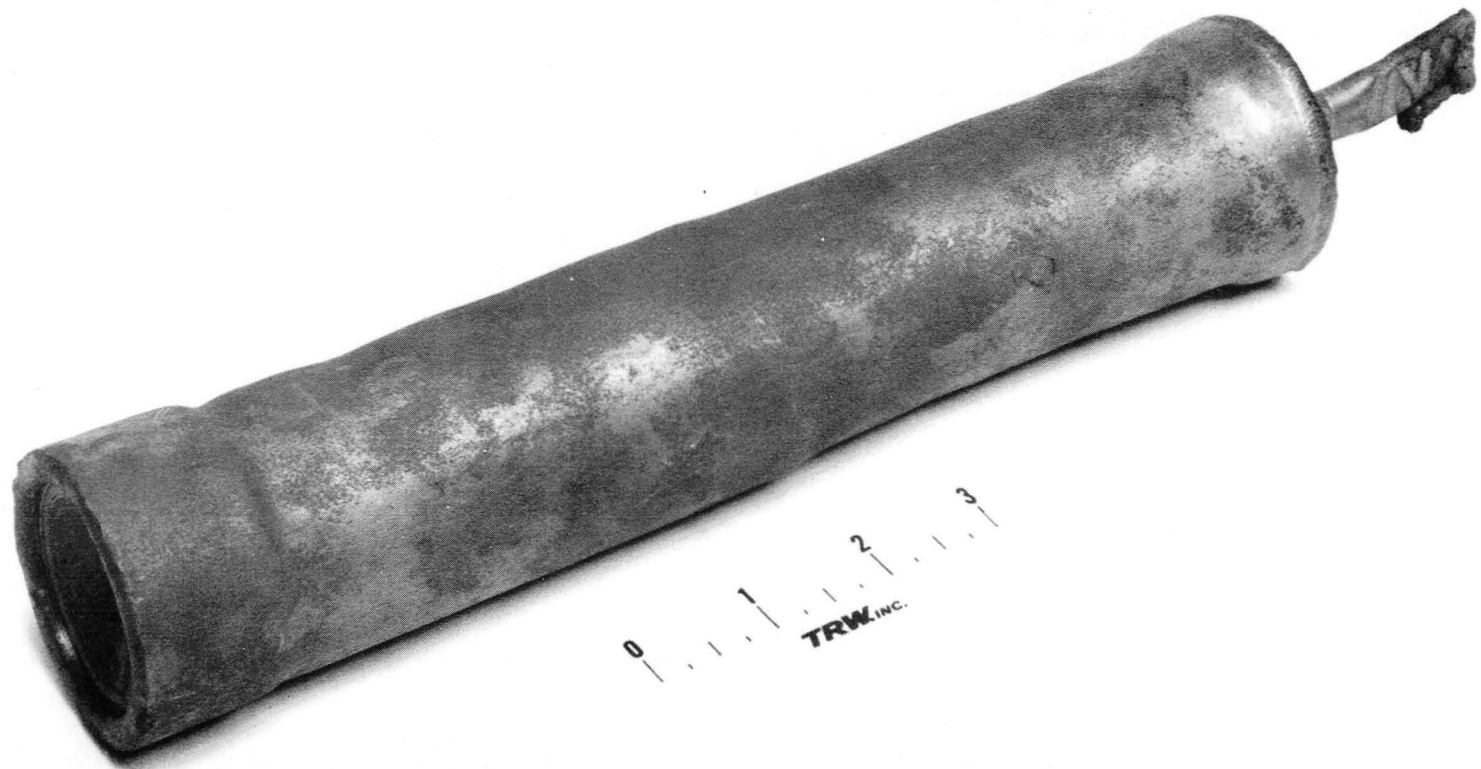
Figure 8. Photograph of Typical HIP Consolidated Cylindrically Shaped Can. Scale in Inches.

The initial HIP consolidation operation for Combination A was carried out at IMT using a 25 mm (one inch) diameter 1018 mild steel tube can containing both the rim and hub materials. A typical HIP consolidated cylindrically shaped can is shown in Figure 8. The preliminary consolidation conditions for Combination A included four hours at 1120°C (2050°F) and 105 MPa (15 ksi) and were selected because these conditions have commonly been used for HIP Rene' 95 intended for disk applications (17). The microstructures of the joint and the surrounding rim and hub materials after HIP consolidation are shown in Figure 9. The vacuum sintered Rene' 95 rim material exhibited a grain size of ASTM 1-2, evidence of the grain growth which occurred as a result of the vacuum sinter operation. No additional grain growth during HIP consolidation was observed. However, an appreciable amount of porosity which was present after the vacuum sinter still remained after the HIP operation. This suggested that too low a HIP consolidation temperature was used and that a higher HIP temperature would be required to seal this porosity. For example, Reichman (16) has shown that a 1230°C (2250°F) HIP operation can heal this porosity in coarse grained vacuum sintered Rene' 95. This particular temperature, however, may be too high to maintain a fine grain size in the Rene' 95 hub powder. The loose powder hub material shown in Figure 9 exhibited a fine grained microstructure typical of Rene' 95 HIP'ed at 1120°C (2050°F) for disk applications (17). The interface between the rim and hub materials was generally clean and exhibited no unique features.

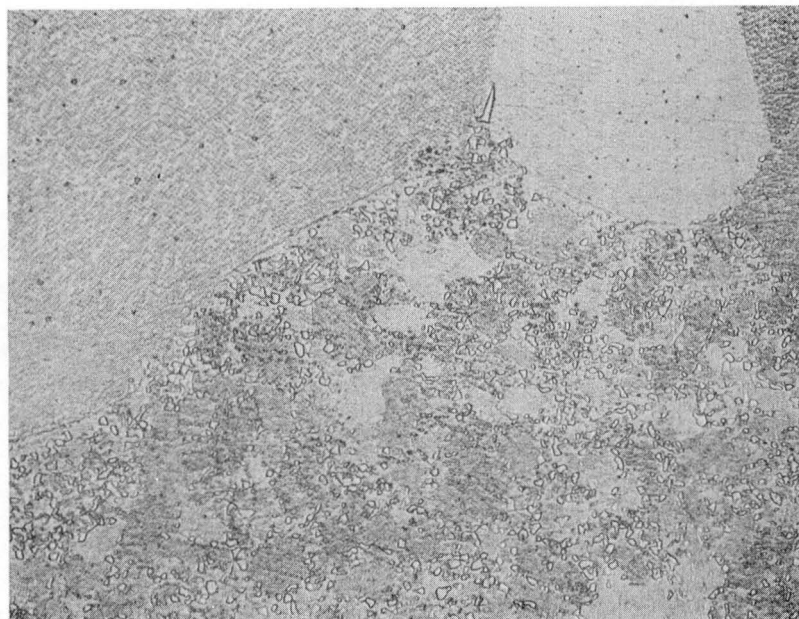
HUB

RIM

JOINT

Figure 9. Light Photomicrographs of Microstructure of Joint Region of Combination A Material HIP Joined for Four Hours at 1120°C (2050°F)/105 MPa (15 ksi).

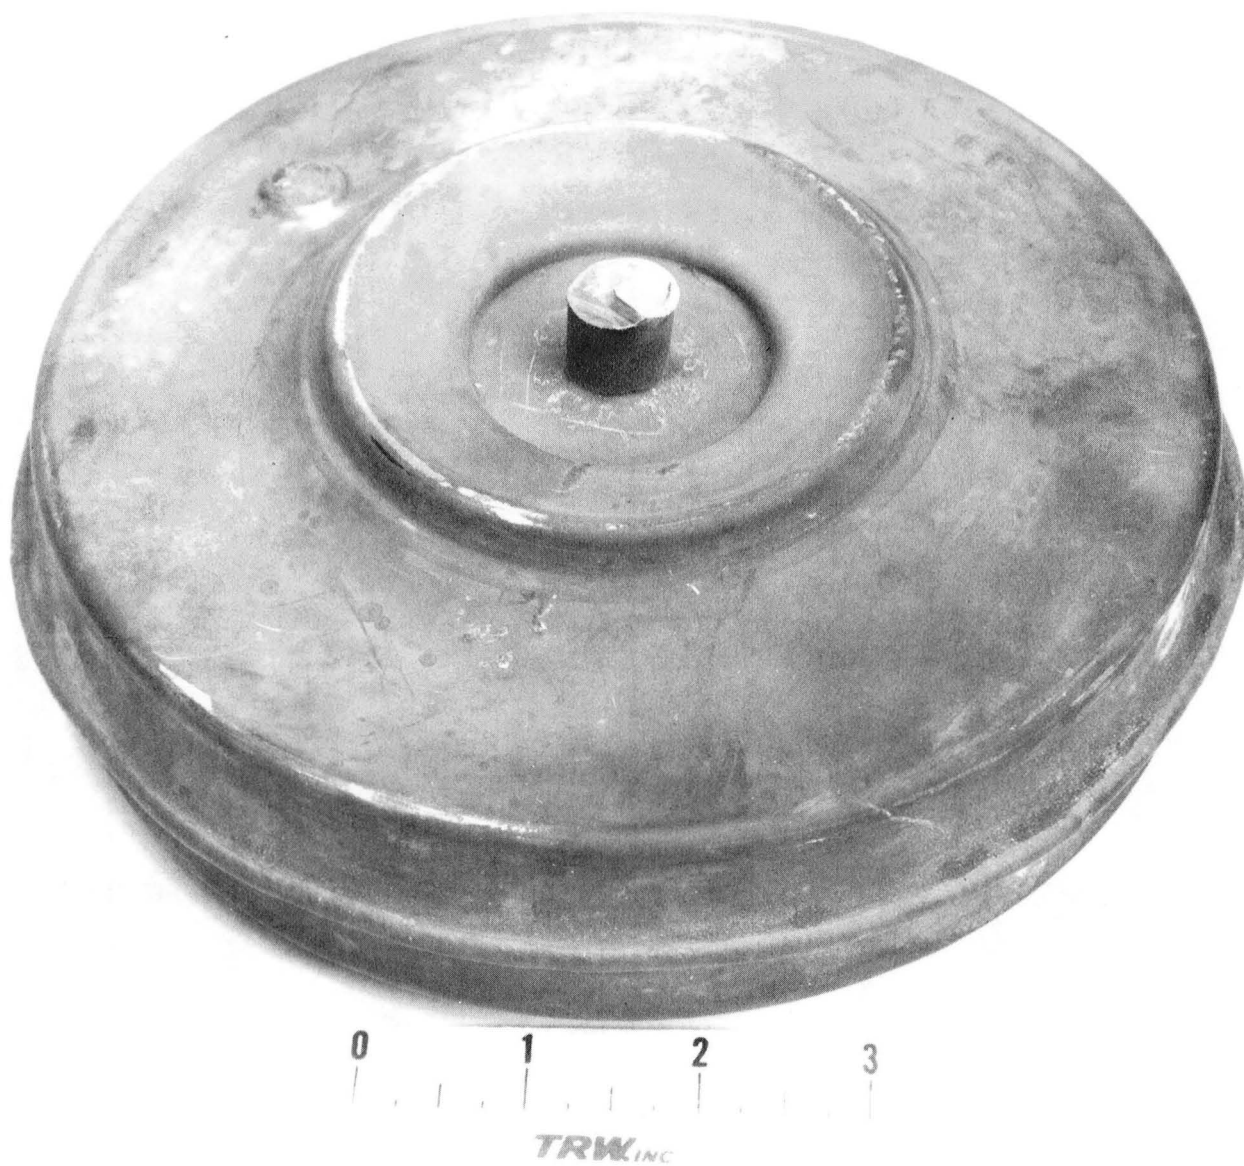
Figure 58. Photograph of Combination C T-700 Disk in the as-HIP Condition. Scale in Inches.

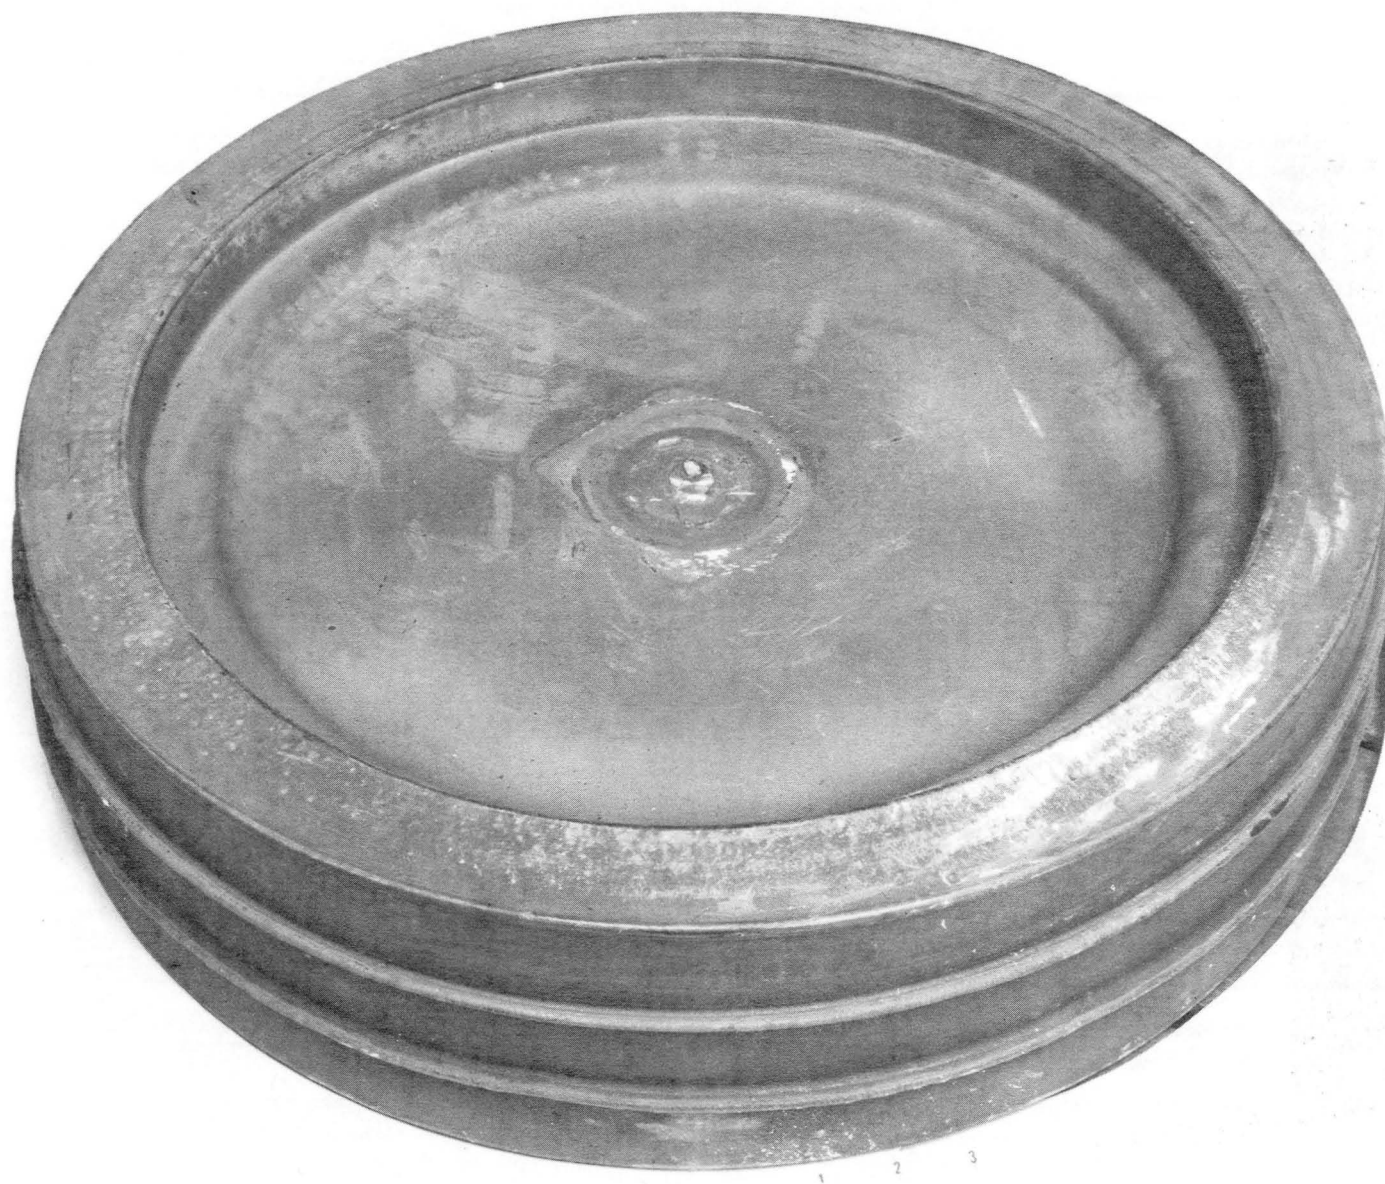
Figure 65. Photograph of CFM-56 Disk in as-HIP'ed Condition. Scale in Inches.

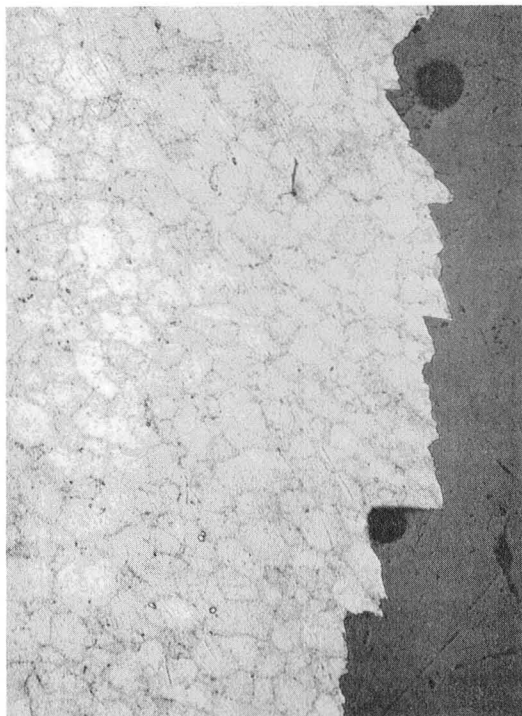
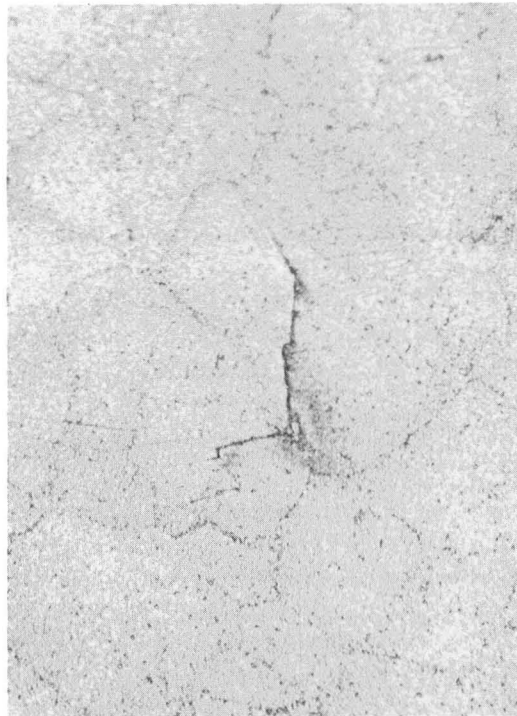
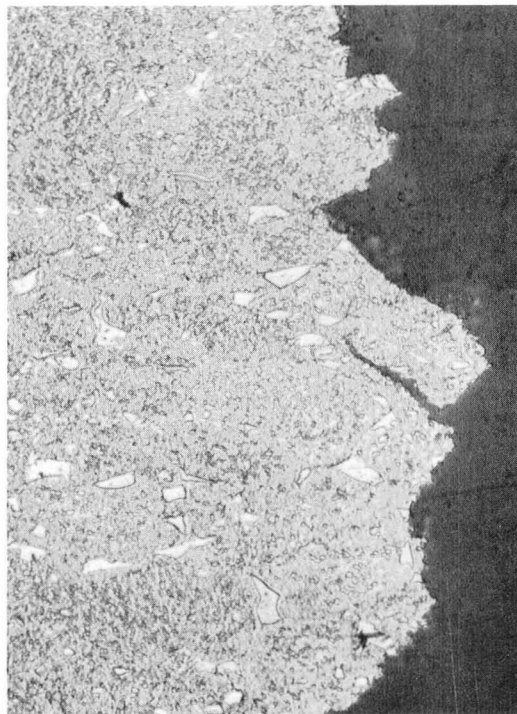
(a) Rene' 95, 100X

(b) Rene' 95, 500X

(d) AF-115, 500X

Figure 74. Light Photomicrographs of Typical Fracture Surfaces of Rene' 95 and AF-115 Tensile Specimens from CFM-56 Disk Tested at 650°C (1200°F).

A comparison of the CFM-56 Rene' 95 and AF-115 data for comparable test temperatures indicated that the AF-115 ultimate strength was superior at 480°C (900°F) (to the point of being within 98% of the program goal) and comparable at 650°C (1200°F). The yield strengths were comparable and the ductility values indicated AF-115 was superior over the test temperature range. The failures were predominantly transgranular for both alloys as shown in Figure 74 for materials tested at 650°C (1200°F).
